DEVELOPMENT AND PROOF SERVICES  
ABERDEEN PROVING GROUND  
MARYLAND

VULNERABILITY TO BALLISTIC ATTACK OF OSCILLATING TANK TURRETS

FIRST REPORT ON PROJECT TT2-586

ARMOR TEST REPORT NO. AD-1186

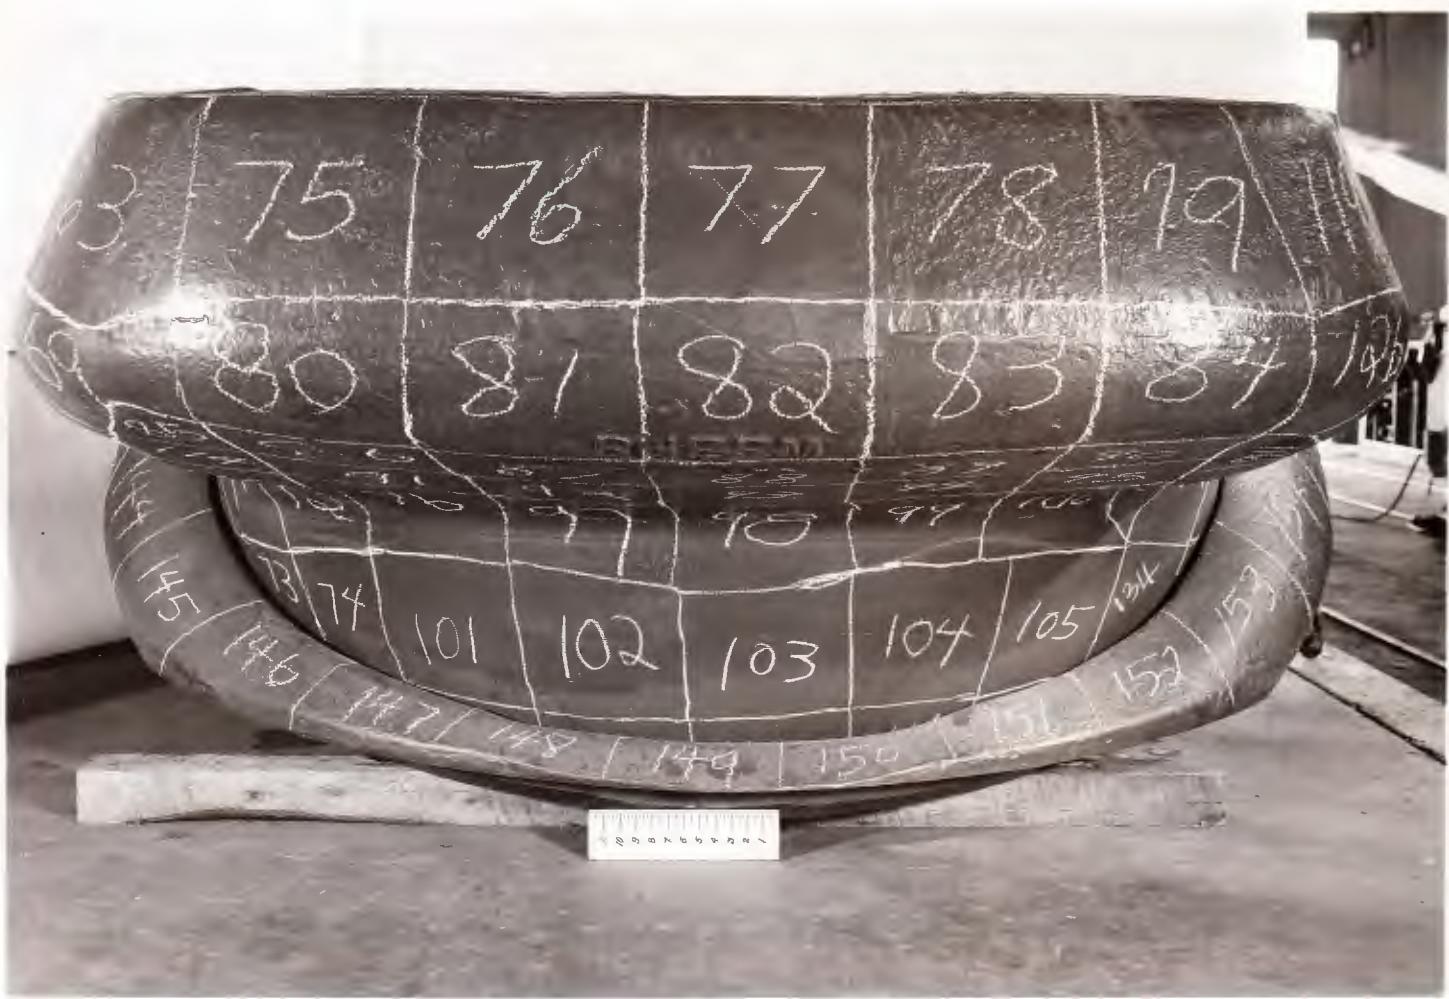
188718 CONFIDENTIAL ABERDEEN PROVING GROUND 20 April 1953  
Project No. TT2-586. Tank, Turret, Oscillating, Serial No. 3.  
Rear view showing thickness measurement locations before test at APG.

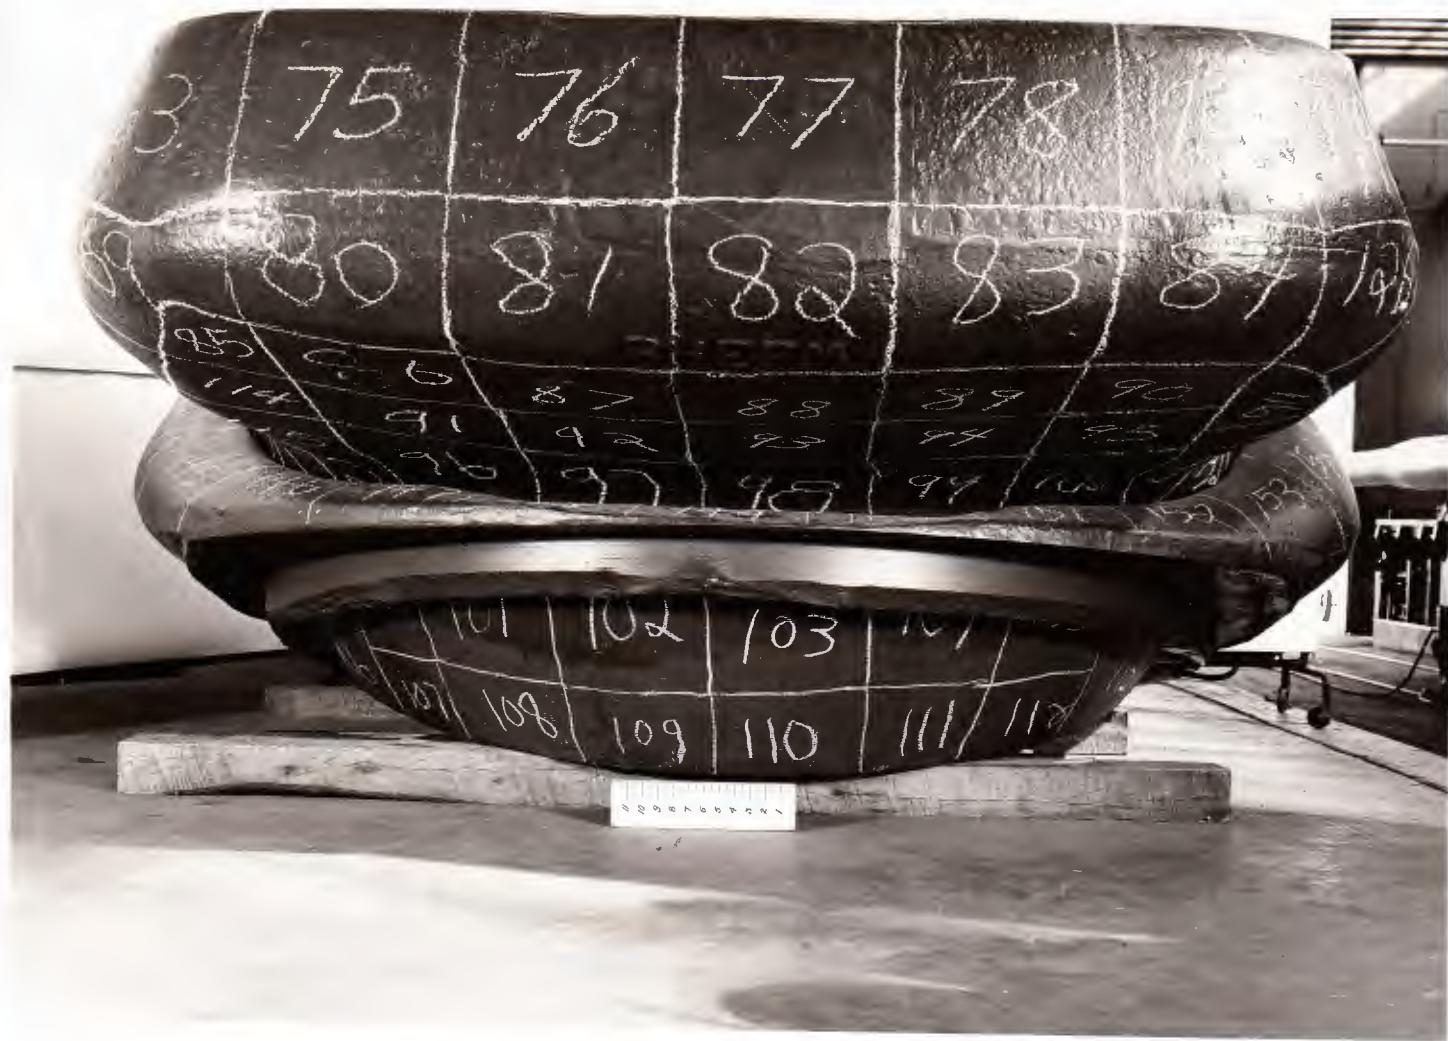
188719 CONFIDENTIAL ABERDEEN PROVING GROUND 20 April 1953  
Project No. TT2-586. Tank, Turret, Oscillating, Serial No. 3.  
Rear view showing thickness measurement locations before test at APG.

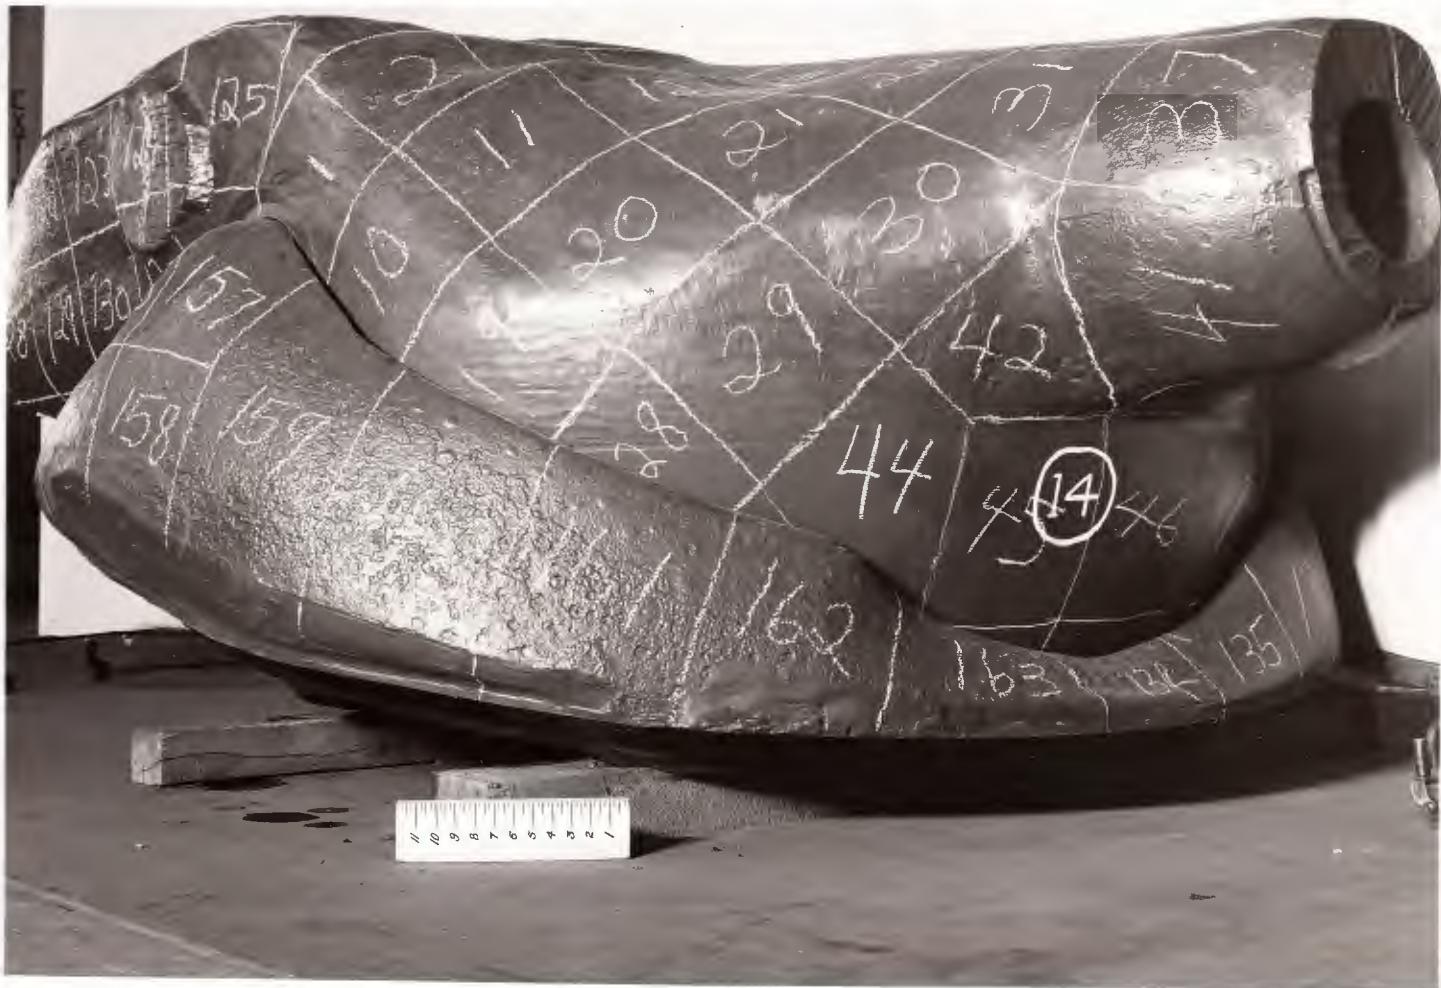
A88720 CONFIDENTIAL 8 ABERDEEN PROVING GROUND 8 20 April 1953  
Project No. TT2-586. Tank, Turret, Oscillating, Serial No. 3.  
Three-quarter right front view showing thickness measurement  
locations before test at APG.

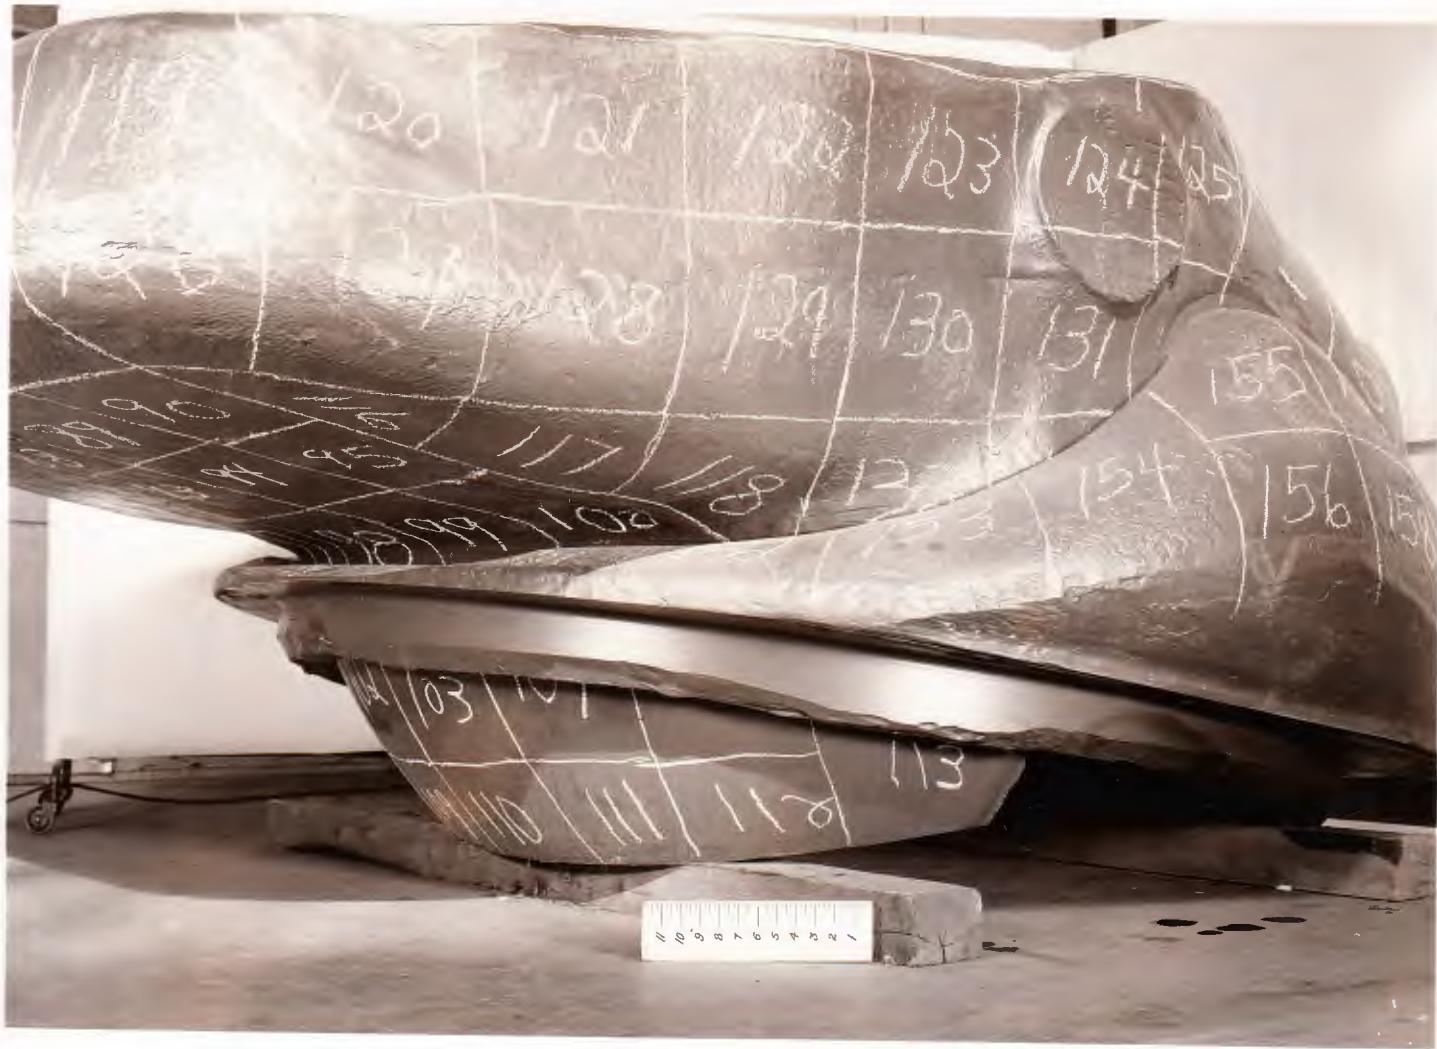
A88725 CONFIDENTIAL 8 ABERDEEN PROVING GROUND 8 20 April 1953  
Project No. TT2-586. Tank, Turret, Oscillating, Serial No. 3.  
Three-quarter right rear view showing thickness measurement locations  
before test at APG.

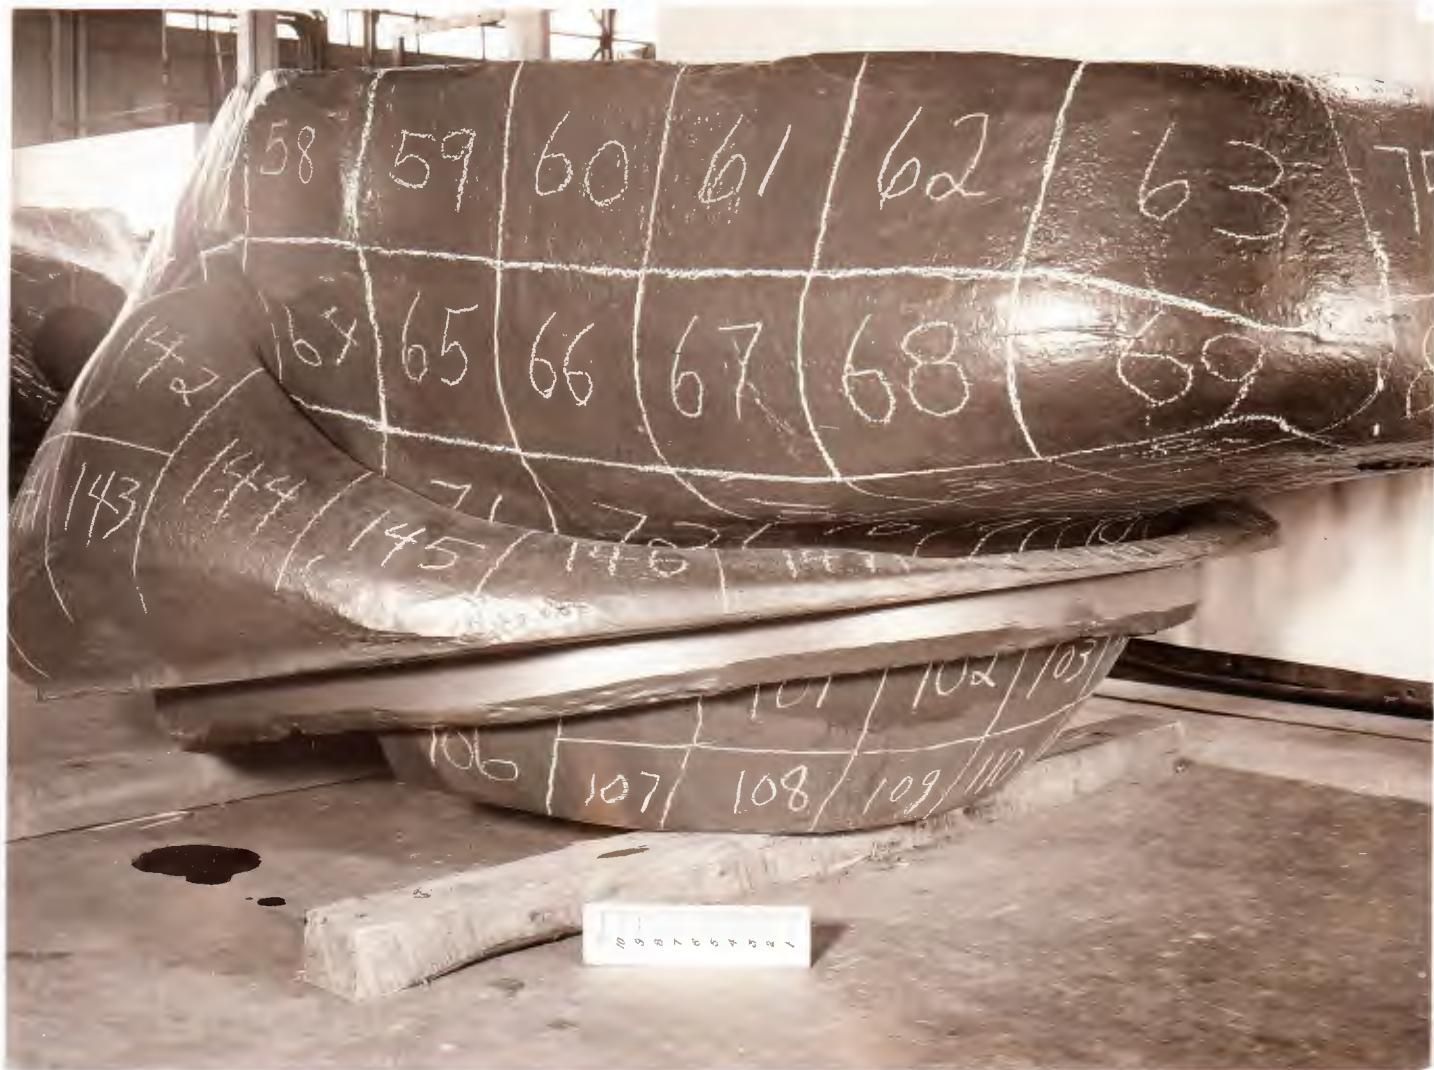
A88726 CONFIDENTIAL § ABERDEEN PROVING GROUND §

Three-quarter left rear view showing thickness measurement locations  
before test at APG.

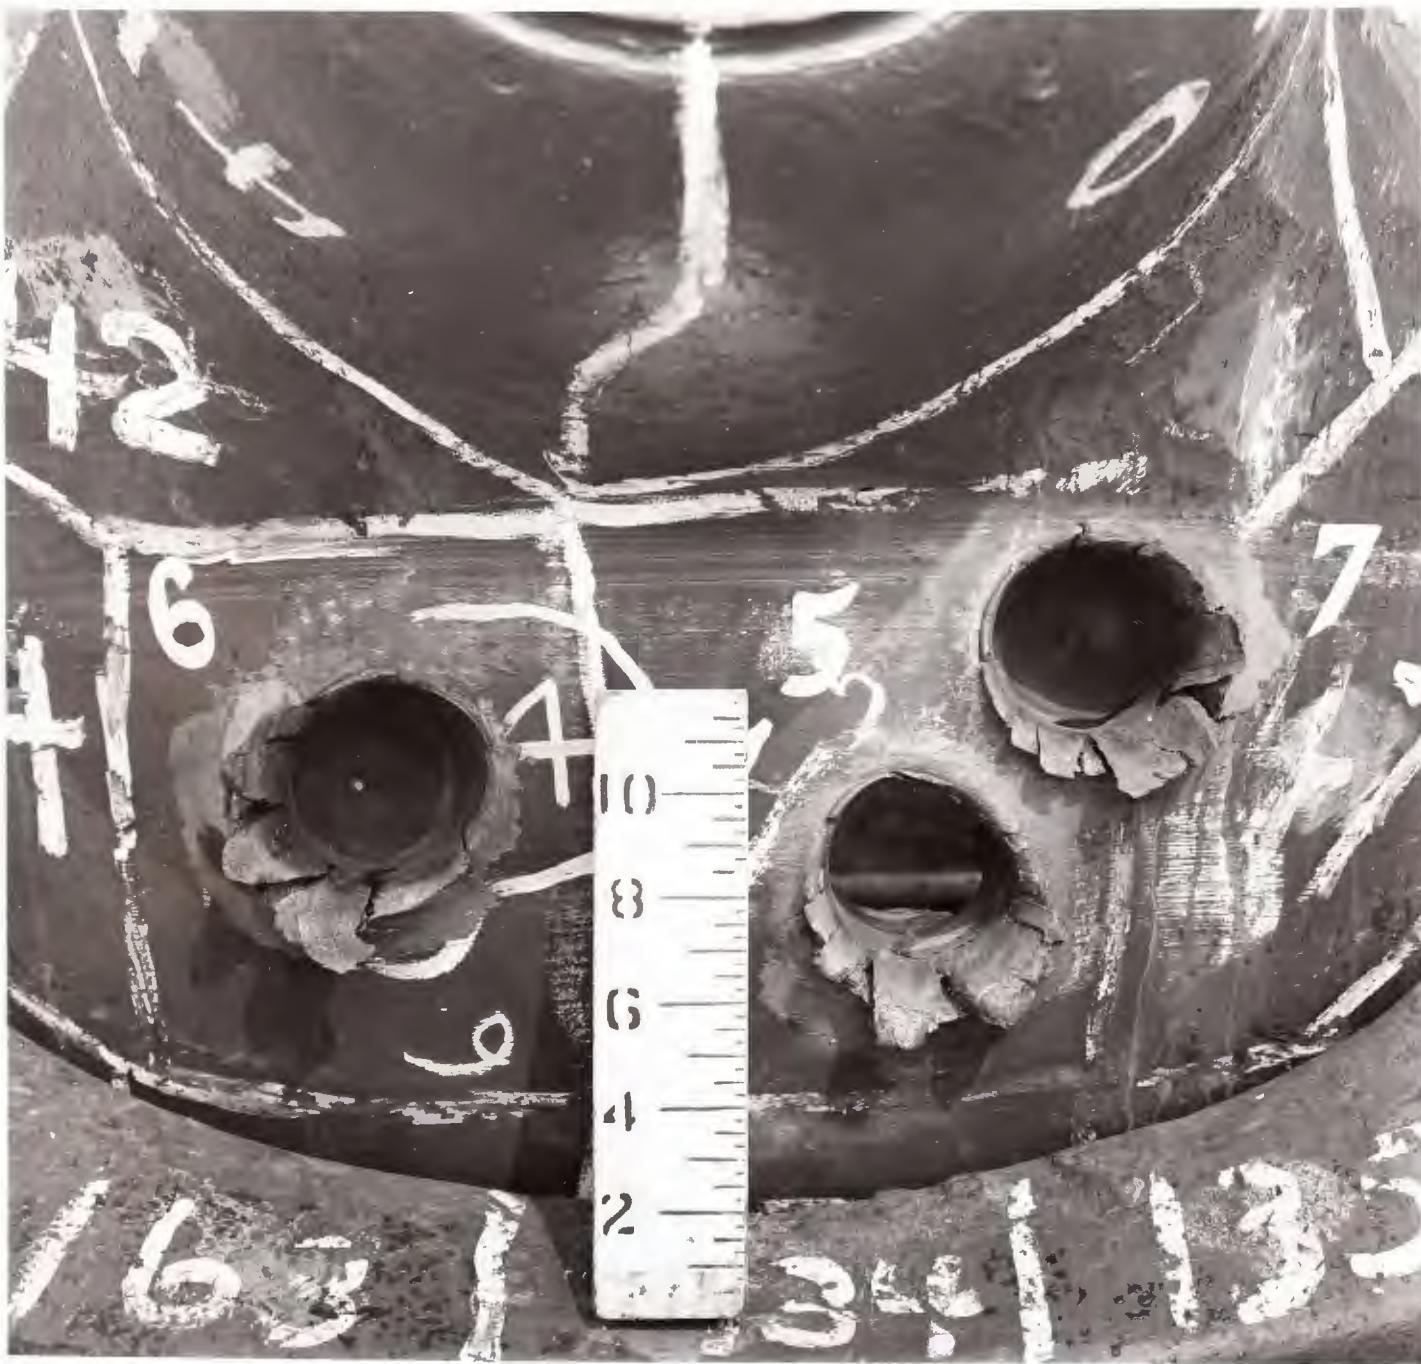
A89570 CONFIDENTIAL § ABERDEEN PROVING GROUND §

- (3) One 90mm AP, T33 projectile hit under the gun near the rotating ring and produced face petalling of the armor which pinned the oscillating turret section to the rotating ring and prevented further elevation and depression of the turret. It is felt that much smaller projectiles could produce the same results if they remained in the armor after impact or produced large enough petals on the surface. (See APG Photograph A89570 Appendix F, Sub-Appendix 1).
